**Flood Control Project Maintenance
Levee Inspections**

Maintenance Issue Types Only, Levee Inspection Report By Mile - Spring 2020

Reclamation District No. 0108 River Farms

Waterway	Bank	Unit Miles	Inspection Start/End	Inspector
Unit No. 01 Colusa Basin Drain	Left	20.64	03/25/2020 03/25/2020	Zach Jojola

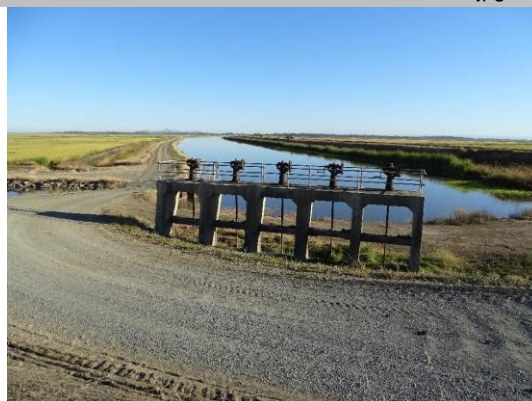
Photo 1 of 3 : UCIP_SP_2020_55919_83215.jpg

Comment Code						
Inspector Comment						
DS_ID:17943 FS_ID:55919 EP_NO: 9736 Repair Type: Non-Urgent Crossing Status: Found UCIP Comments: 10/2/2019 Record remains Non-Urgent. In 2019 RD 108 took an attempt to bring structure to operable condition. Although this attempt was unsuccessful District will review other options. In the meantime crossing considered abandoned. Need to have CVFPB review ABO and determine current owner. (O.Yakimov - DWR UCIP) 06/10/2014 Need to contact owner to determine status of structure. Notes indicate crossing has been abandoned. Owner will need to coordinate with CVFPB and DWR inspector to determine how to properly abandon. (O.Magana - DWR UCIP) FIELD_STRUCT_DESC: *ABANDONED* 1 of 5: 72-inch reinforced concrete gravity drainage pipe or culvert through the levee, 31.6 feet below the crown. Slide gate on each end. (Retention of five 72-inch pipes through the levee [HLM 0.08] authorized under Automatic Board Order (ABO) issued as Permit No. 9736, 1974 - Reclamation District No. 108 [RD0108]). [Additional Reference(s): DWR Levee Log, 1991, (HLM 0.08). USACE Sacramento O&M Manual 132, October 1959, (HLM 0.08), referenced as five 6-foot by 8-foot concrete drainage culverts]. FS Date: 10/2/2019

View of LS looking from levee crown

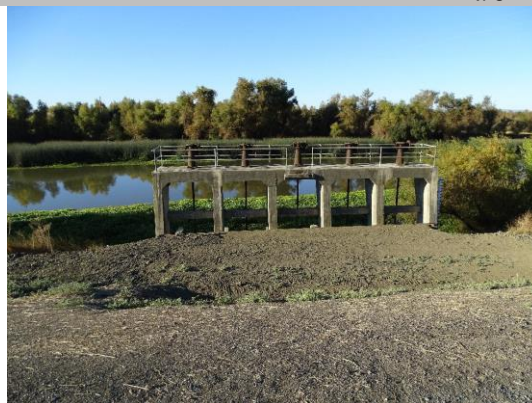
Photo 2 of 3 : UCIP_SP_2020_55919_83216.jpg

View of WS looking from levee crown

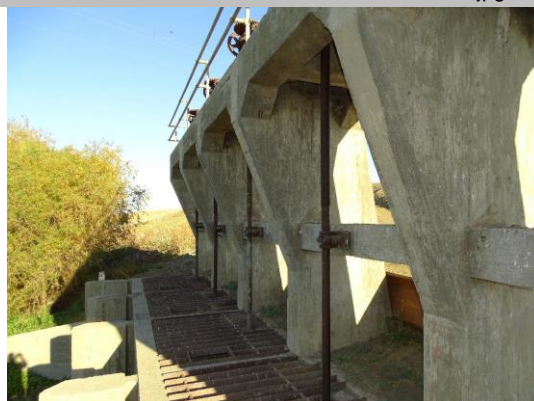
Photo 3 of 3 : UCIP_SP_2020_55919_83217.jpg

Slide gate operating structure on WS shoulder

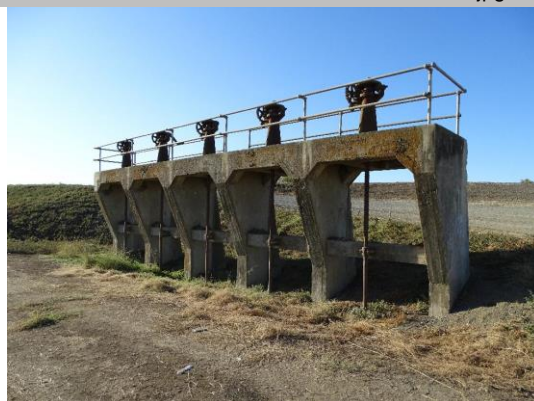
Photo 1 of 3 : UCIP_SP_2020_55920_83222.jpg

DS_ID:22386
 FS_ID:55920
 EP_NO: 9396
 Repair Type: Non-Urgent
 Crossing Status: Found
 UCIP Comments: 8/2/2019 Record remains Non-Urgent. In 2019 RD 108 took an attempt to bring structure to operable condition. Although this attempt was unsuccessful District will review other options. In the meantime crossing considered abandoned. Need to have CVFPB review ABO and determine current owner. (O.Yakimov - DWR UCIP) 06/10/2014 Need to contact owner to determine status of structure. Notes indicate crossing has been abandoned. Owner will need to coordinate with CVFPB and DWR inspector to determine how to properly abandon. (O.Magana - DWR UCIP)
 FIELD_STRUCT_DESC: *ABANDONED* 2 of 5: 72-inch reinforced concrete gravity drainage pipe or culvert through the levee, 31.6 feet below the crown. Slide gate on each end. (Retention of five 72-inch pipes through the levee [HLM 0.08] authorized under Automatic Board Order (ABO) issued as Permit No. 9736, 1974 - Reclamation District No. 108 [RD0108]). [Additional Reference(s): DWR Levee Log, 1991, (HLM 0.08). USACE Sacramento O&M Manual 132, October 1959, (HLM 0.08), referenced as five 6-foot by 8-foot concrete drainage culverts].

View of concrete structure located on landward side

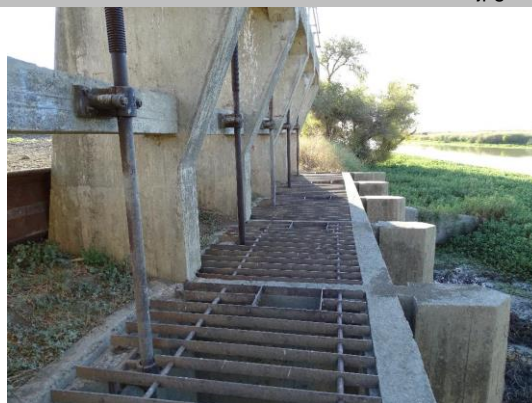
Photo 2 of 3 : UCIP_SP_2020_55920_83226.jpg

Slide gates on waterward side

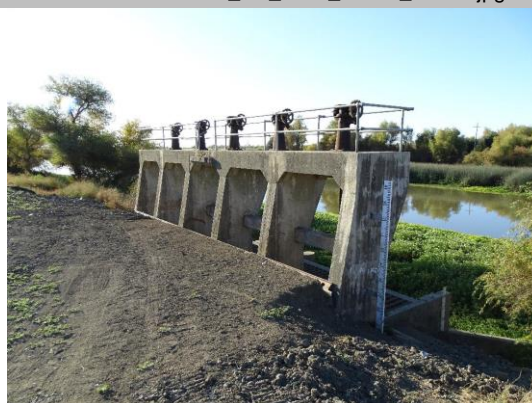
Photo 3 of 3 : UCIP_SP_2020_55920_83227.jpg

Concrete structure located on waterward side

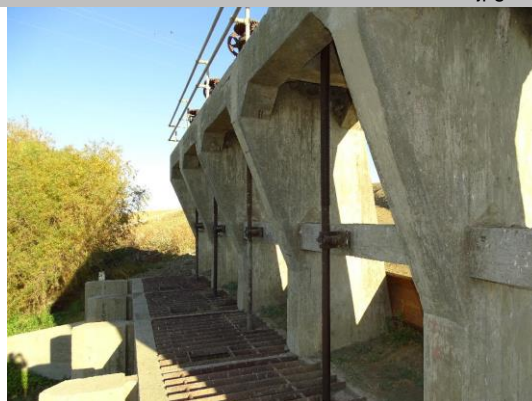
Photo 1 of 3 : UCIP_SP_2020_55921_83223.jpg

Comment Code					
Inspector Comment					
DS_ID:22387 FS_ID:55921 EP_NO: 9396 Repair Type: Non-Urgent Crossing Status: Found UCIP Comments: 10/2/2019 Record remains Non-Urgent. In 2019 RD 108 took an attempt to bring structure to operable condition. Although This attempt was unsuccessful District will review other options. In the meantime crossing considered abandoned. Need to have CVFPB review ABO and determine current owner. (O.Yakimov - DWR UCIP)06/10/2014 Need to contact owner to determine status of structure. Notes indicate crossing has been abandoned. Owner will need to coordinate with CVFPB and DWR inspector to determine how to properly abandon. (O.Magana - DWR UCIP) FIELD_STRUCT_DESC: *ABANDONED* 3 of 5: 72-inch reinforced concrete gravity drainage pipe or culvert through the levee, 31.6 feet below the crown. Slide gate on each end. (Retention of five 72-inch pipes through the levee [HLM 0.08] authorized under Automatic Board Order (ABO) issued as Permit No. 9736, 1974 - Reclamation District No. 108 [RD0108]). [Additional Reference(s): DWR Levee Log, 1991. USACE Sacramento O&M Manual 132, October 1959, (HLM 0.08), referenced as five 6-foot by 8-foot concrete drainage culverts]. FS Date: 10/2/2019 7:54:00 AM

Slide gates on waterward side

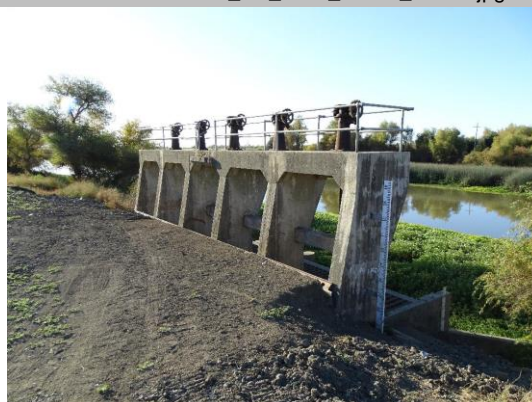
Photo 2 of 3 : UCIP_SP_2020_55921_83224.jpg

Concrete structure located on waterward side

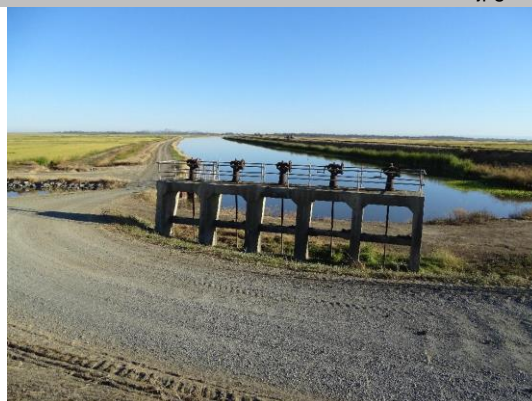
Photo 1 of 3 : UCIP_SP_2020_55922_83228.jpg

View of concrete structure located on landward side

Comment Code					
Inspector Comment					
DS_ID:22388 FS_ID:55922 EP_NO: 9396 Repair Type: Non-Urgent Crossing Status: Found UCIP Comments: 10/2/2019 Record remains Non-Urgent. In 2019 RD 108 took an attempt to bring structure to operable condition. Although this attempt was unsuccessful District will review other options. In the meantime crossing considered abandoned. Need to have CVFPB review ABO and determine current owner. (O.Yakimov - DWR UCIP)06/10/2014 Need to contact owner to determine status of structure. Notes indicate crossing has been abandoned. Owner will need to coordinate with CVFPB and DWR inspector to determine how to properly abandon. (O.Magana - DWR UCIP) FIELD_STRUCT_DESC: *ABANDONED* 4 of 5: 72-inch reinforced concrete gravity drainage pipe or culvert through the levee, 31.6 feet below the crown. Slide gate on each end. (Retention of five 72-inch pipes through the levee [HLM 0.08] authorized under Automatic Board Order (ABO) issued as Permit No. 9736, 1974 - Reclamation District No. 108 [RD0108]). [Additional Reference(s): DWR Levee Log, 1991, (HLM 0.08). USACE Sacramento O&M Manual 132, October 1959, (HLM 0.08), referenced as five 6-foot by 8-foot concrete drainage culverts]. FS Date: 10/2/2019 7:59:18 AM

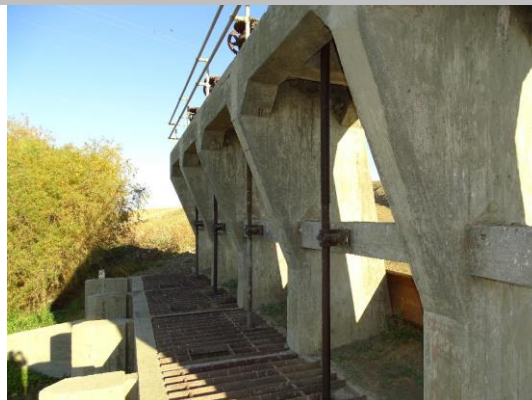
Photo 3 of 3 : UCIP_SP_2020_55922_83230.jpg

Slide gates on waterward side

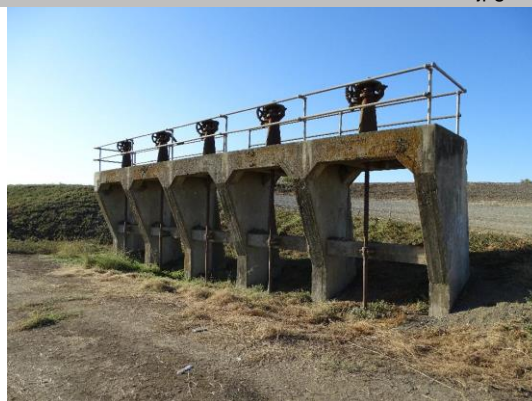
Photo 1 of 3 : UCIP_SP_2020_55923_83231.jpg

Comment Code						
Inspector Comment						
DS_ID:22389 FS_ID:55923 EP_NO: 9396 Repair Type: Non-Urgent Crossing Status: Found UCIP Comments: 10/2/2019 Record remains Non-Urgent. In 2019 RD 108 took an attempt to bring structure to operable condition. Although this attempt was unsuccessful District will review other options. In the meantime crossing considered abandoned. Need to have CVFPB review ABO and determine current owner. (O.Yakimov - DWR UCIP)06/10/2014 Need to contact owner to determine status of structure. Notes indicate crossing has been abandoned. Owner will need to coordinate with CVFPB and DWR inspector to determine how to properly abandon. (O.Magana - DWR UCIP) FIELD_STRUCT_DESC: *ABANDONED* 5 of 5: 72-inch reinforced concrete gravity drainage pipe or culvert through the levee, 31.6 feet below the crown. Slide gate on each end. (Retention of five 72-inch pipes through the levee [HLM 0.08] authorized under Automatic Board Order (ABO) issued as Permit No. 9736, 1974 - Reclamation District No. 108 [RD0108]). [Additional Reference(s): DWR Levee Log, 1991. USACE Sacramento O&M Manual 132, October 1959, (HLM 0.08), referenced as five 6-foot by 8-foot concrete drainage culverts]. FS Date: 10/2/2019 8:01:09 AM

View of concrete structure located on landward side

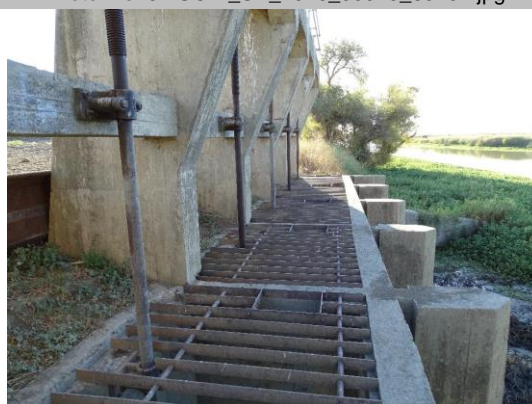
Photo 2 of 3 : UCIP_SP_2020_55923_83232.jpg

Slide gates on waterward side

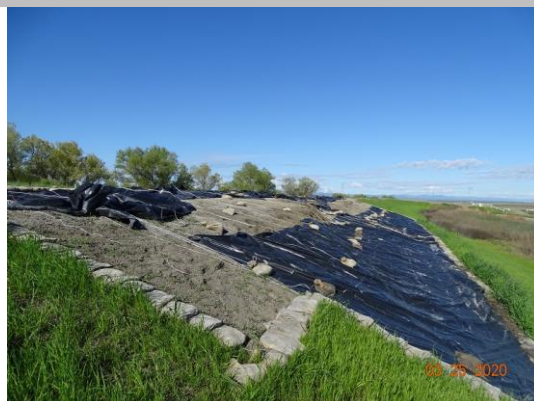
Photo 1 of 3 : SP_2020_RD0108_203_15_20200325_00041.jpg

LM Start	2.70	Rating **	M	Issue No.	15
LM End	2.73	Issue Type +	Ma	Location *	LS
Category	Earthen Levee			GPS Latitude/Longitude	
				Start	End
Item	Slope Stability			38.837568 °	38.837749 °
				-121.842218 °	-121.842776 °
DWR ID	DWR_RD0108_01_s_2019_15				
Comment Code					
S1 : Repair slope instability.					
Inspector Comment					
There appears to be a 150' sloughing section that is a result of February 2019 storms. This site will be repaired by the USACE under PL84-99

View of the sloughing site on the landside slope. Spring 2020.

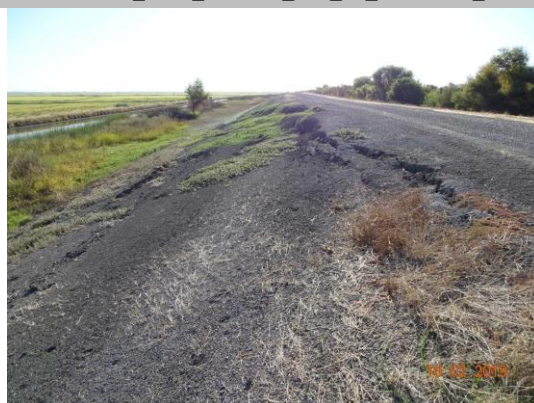
Photo 2 of 3 : SP_2020_RD0108_203_15_20200228_00002.jpg

View of the sloughing on the landside slope. Fall 2019.

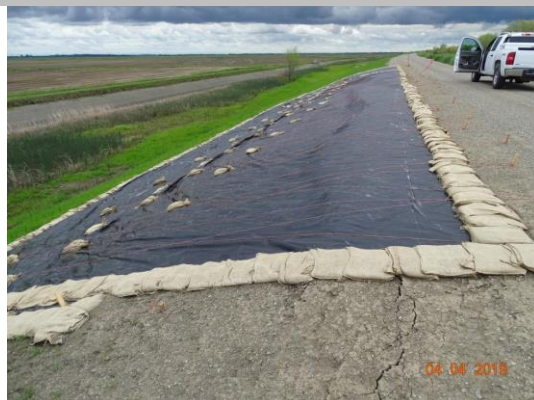
Photo 3 of 3 : SP_2020_RD0108_203_15_20200228_00003.jpg

View of sloughing on the landside slope. Spring 2019.

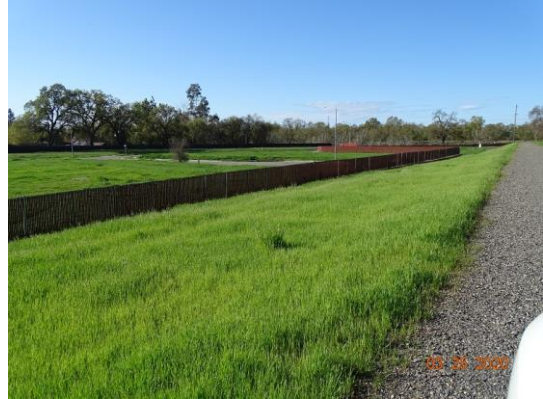
Photo 1 of 1 : SP_2020_RD0108_590_1_20200325_00001.jpg

LM Start	0.03	Rating **	M	Issue No.	1
LM End	0.17	Issue Type +	Ma	Location *	LS
Category	Earthen Levee			GPS Latitude/Longitude	
				Start	End
Item	Vegetation			38.796456 °	38.797952 °
				-121.727472 °	-121.725838 °
DWR ID	DWR_RD0108_02_s_2020_1				
Comment Code					
V1 : Control annual grass and weeds on the levee slopes and easements.					
Inspector Comment

View of vegetation on the landside slope. Spring 2020.
